TECHNICAL INFORMATION

No: 76/08/99/NAS
Ref:
Issue: 2
Date: 05/19/99

Glovebox Area Rattle

DISCOVERY Series II (LT) Up to XA212438

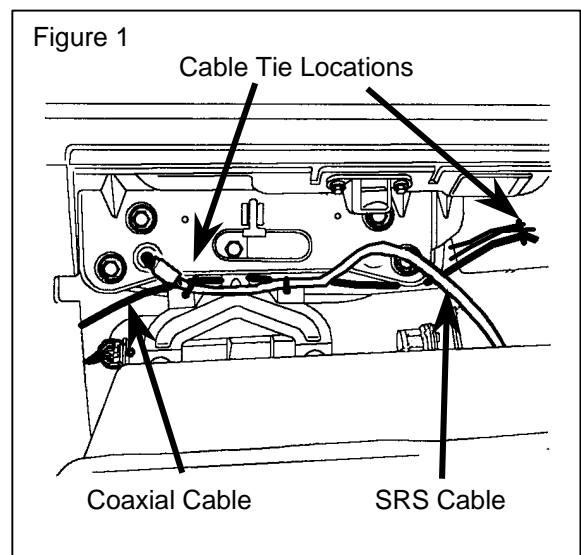
RATTLE NOISE FROM GLOVEBOX AREA

The customer may notice an intermittent rattle from behind the glovebox.

POSITION AND SECURE CABLES BEHIND GLOVEBOX

1. Lower the glove box.
2. Release side latches to drop the glovebox completely down for access behind the dash panel.
3. Inspect to determine that the coaxial cable is located behind the HVAC blower mounting bracket and that it is secured with a cable tie on the left side.
4. If inspection reveals that routing and cable tie are not properly made, remove the two bolts securing the blower-mounting bracket.
5. Locate the cable behind the HVAC blower and install the mounting bracket.
6. Secure the SRS wire and coaxial cable to the blower mounting bracket on left side with a cable tie.
7. If slack is apparent in cable cluster on right side, secure with a cable tie.
